# Electric Service

| IR Text Comment | Value |
|---|---|
| Location | Electric Service |
| Equipment | Pole Transformers |

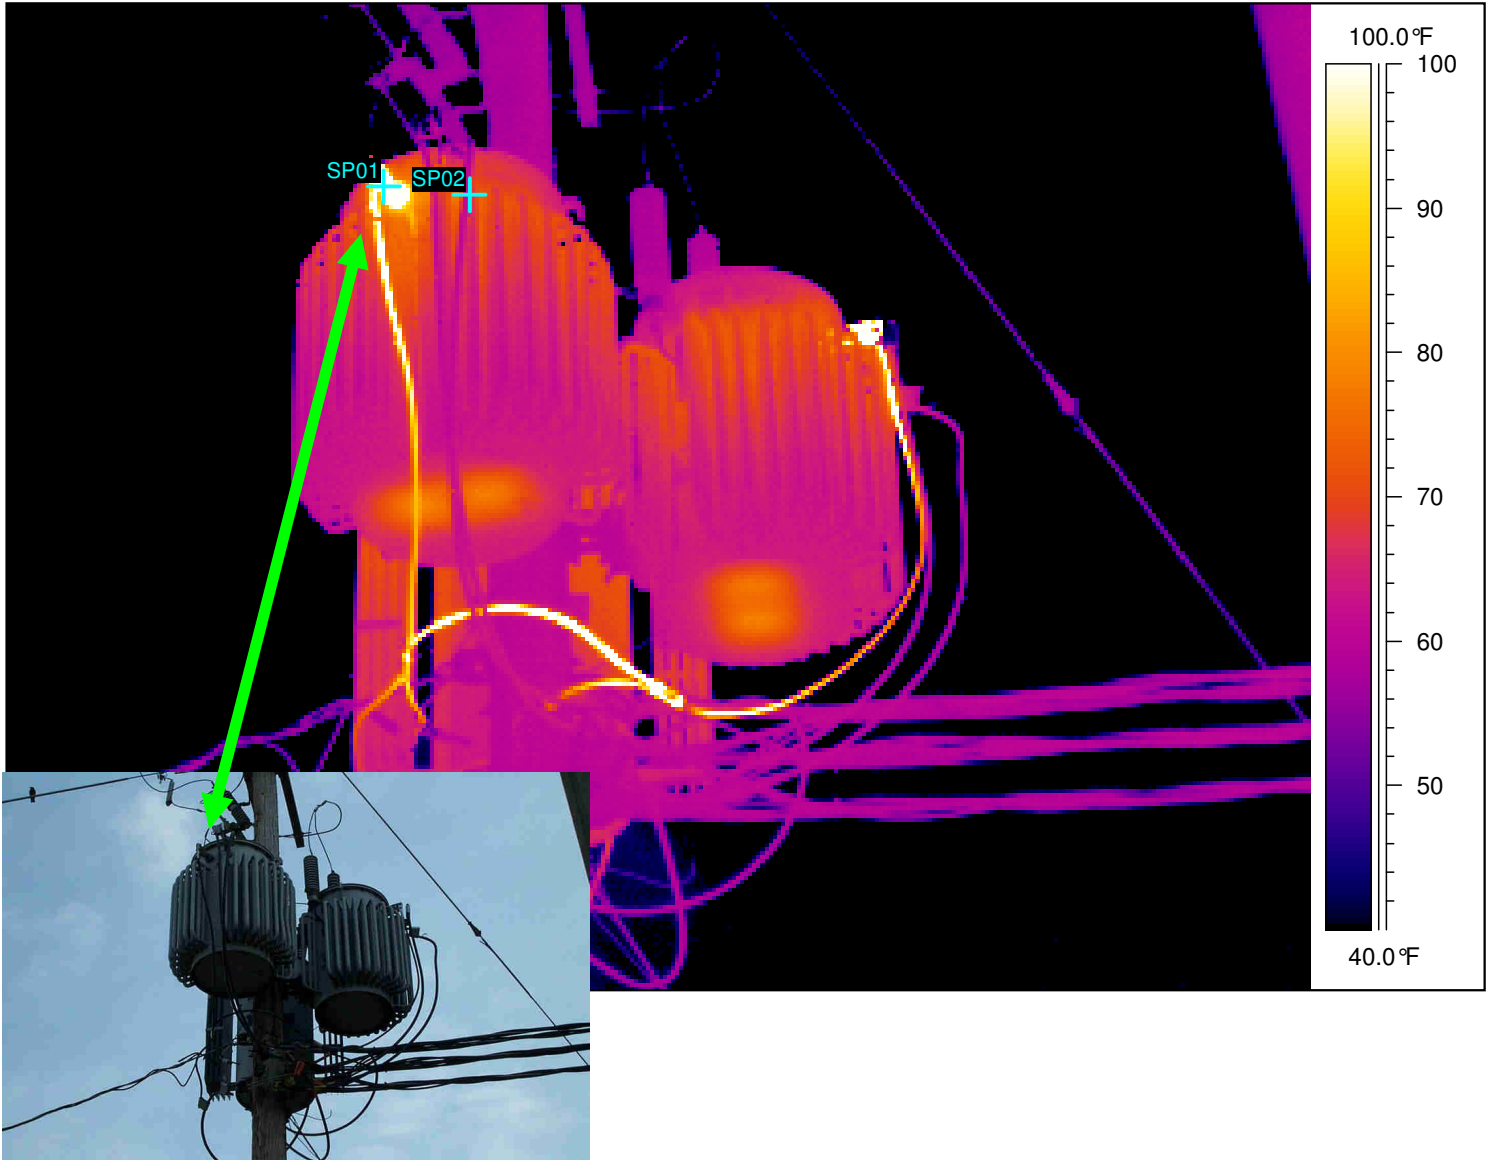
| Spot 1 | 215.7°F | Spot 2 | 64.4°F | Rise | 151.3 °F |

High temperatures on the common terminals on the 480/277 Volt side of the transformers. Temperature rise is compared to the other phase terminal (spot 2). These temperatures should be the same. Conductor size for the common terminals appears to be well undersized. It is also noted that the common neutral conductor is not grounded at the main service disconnect as required by the 2002 National Electrical Code. Further details in the report summary.
